# Community Preservation Committee Town of Arlington

## CPA Funding – FY2020 Final Application

**Community Preservation Committee  
Request for Funding  
Rehabilitation of the Whittemore-Robbins Cottage Exterior**

Re: Whittemore Robbins Cottage  
Structural Engineering Services

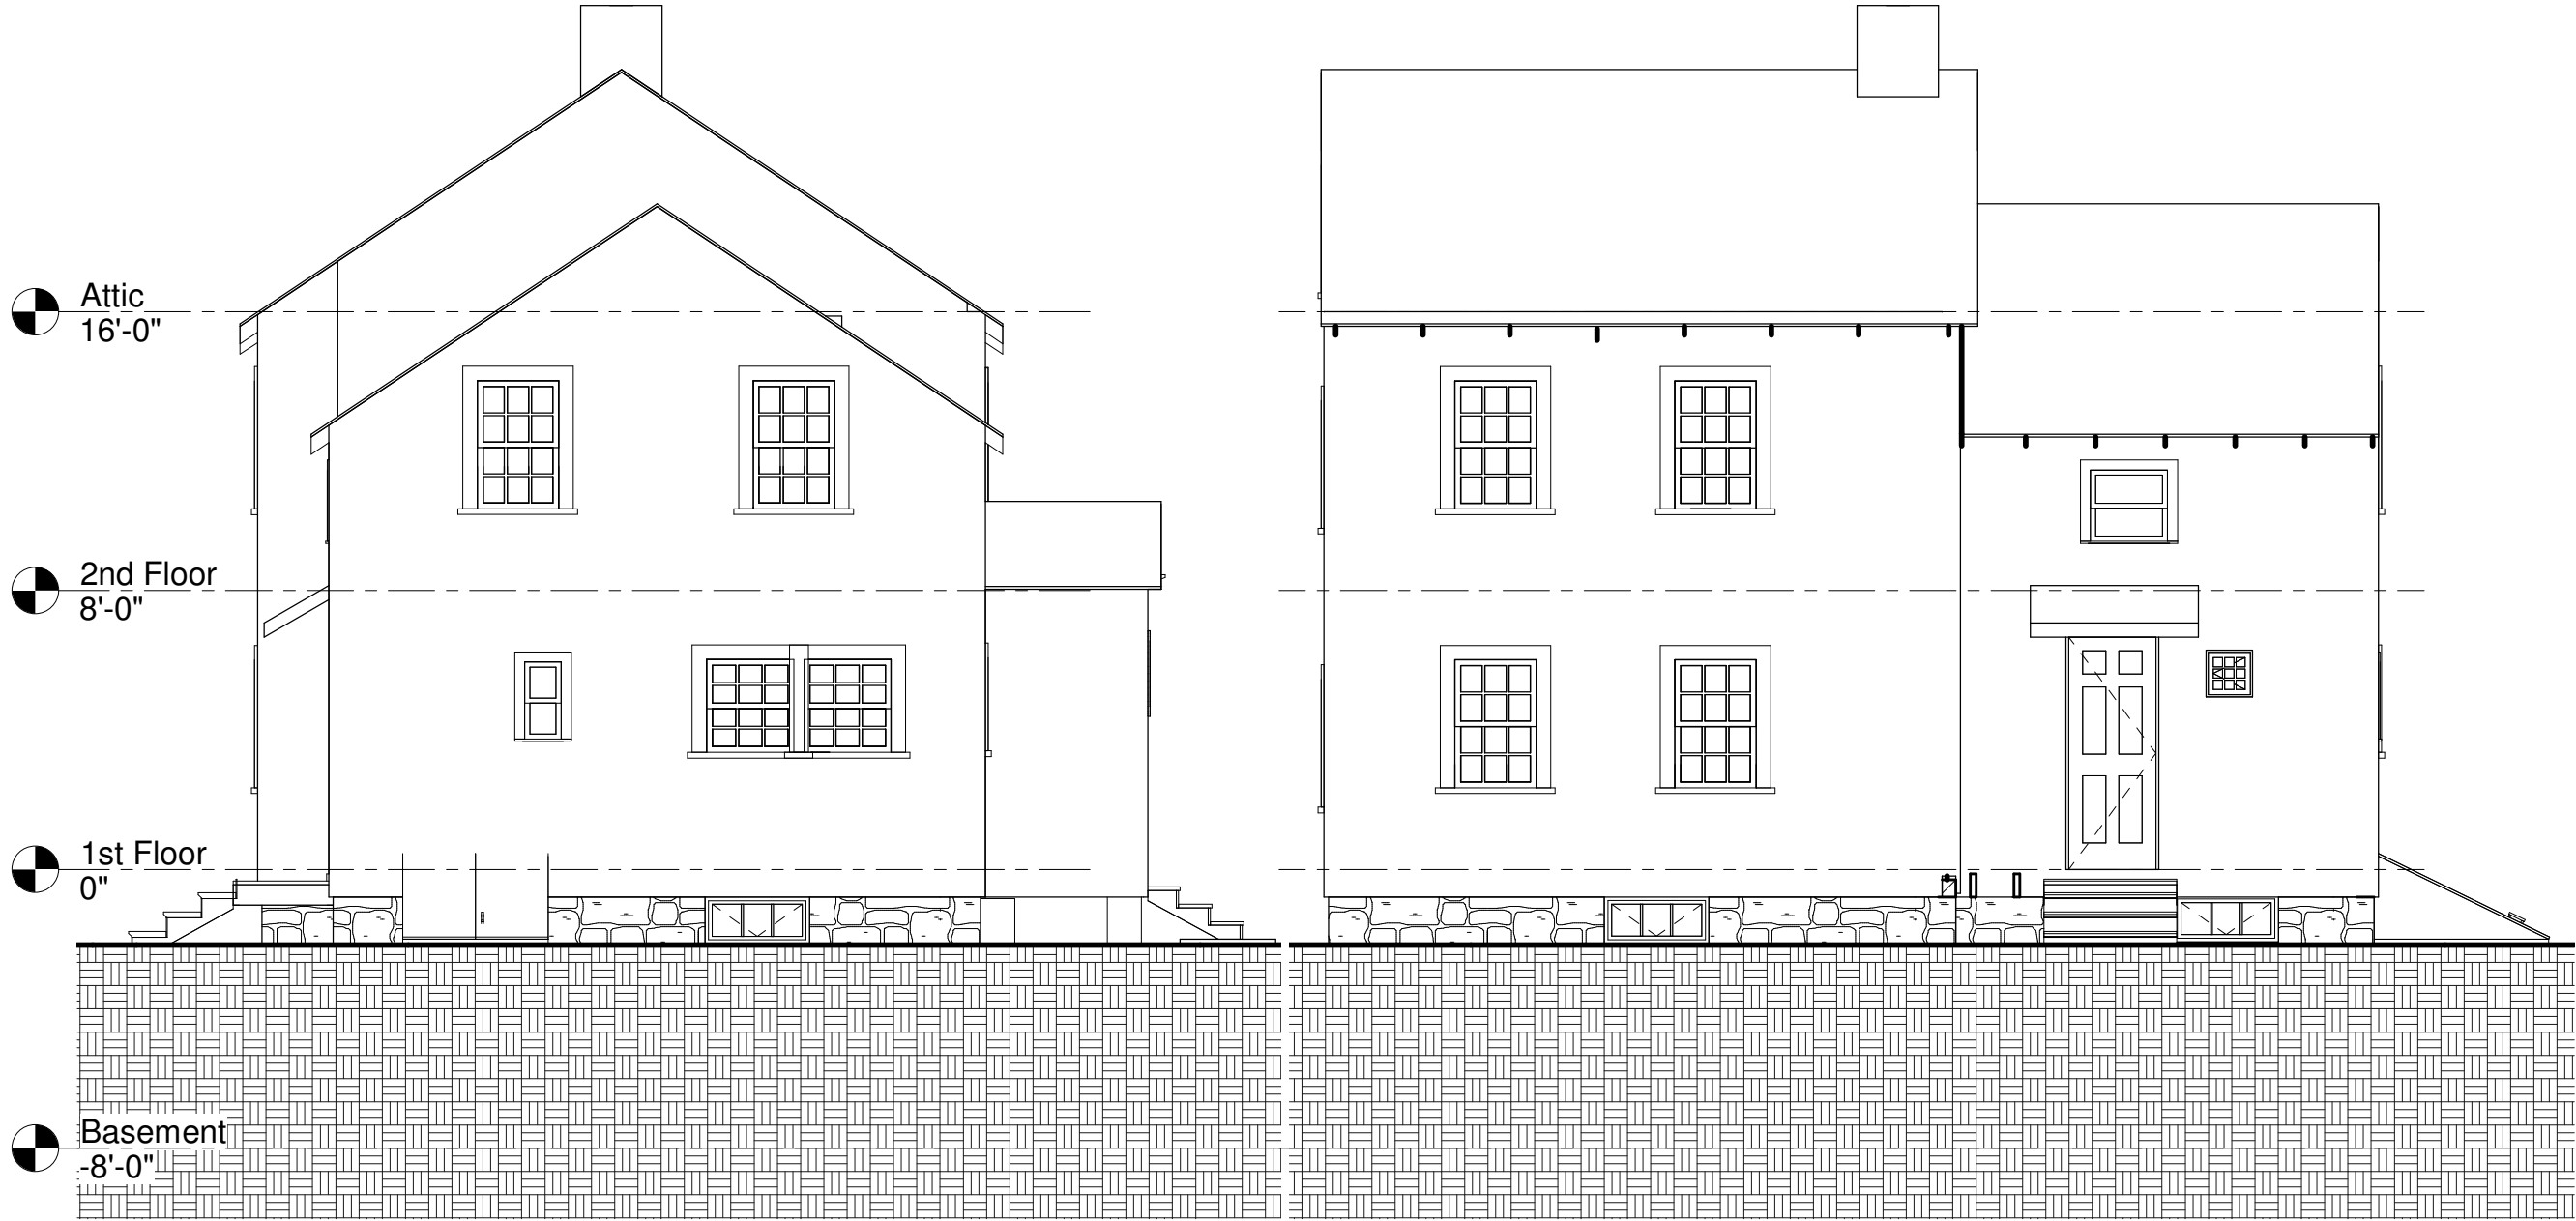
1 South Elevation  
3/16" = 1'-0"

2 West Elevation  
3/16" = 1'-0"

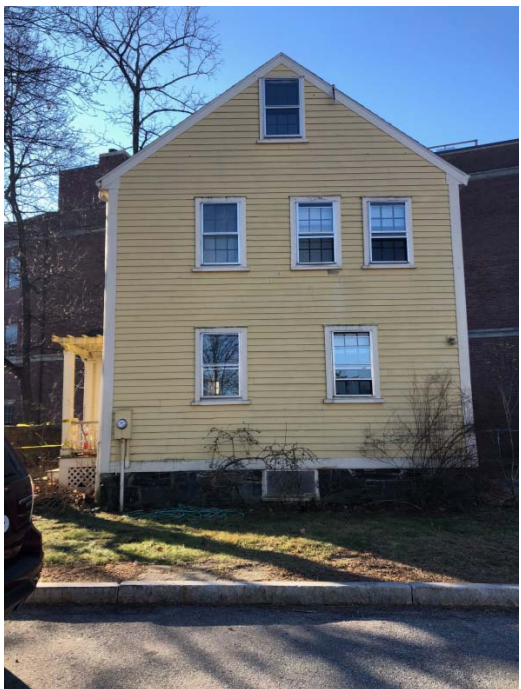
**1. View of Cottage from  
parking lot**

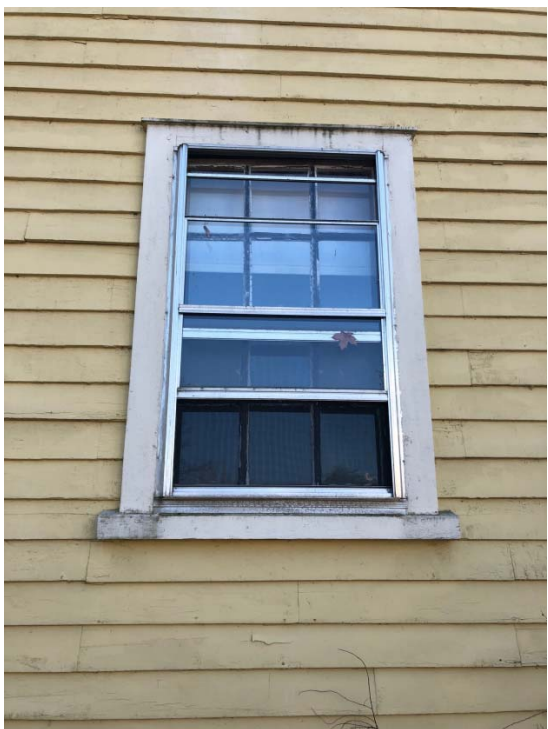
**2. Close up photo of  
window**

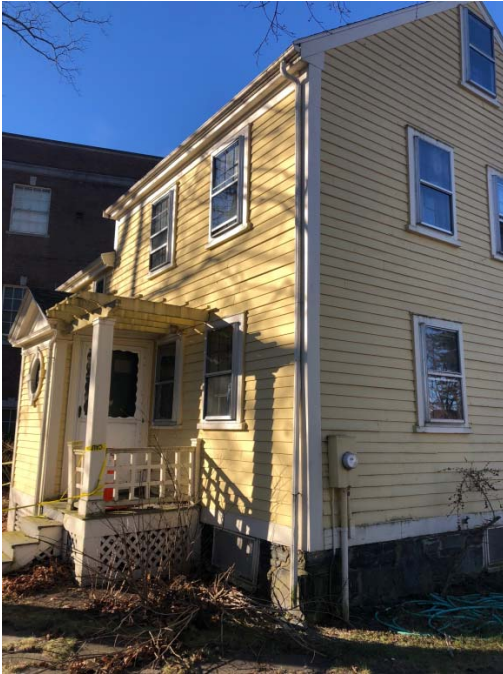
**3. View of east entrance  
from parking lot**

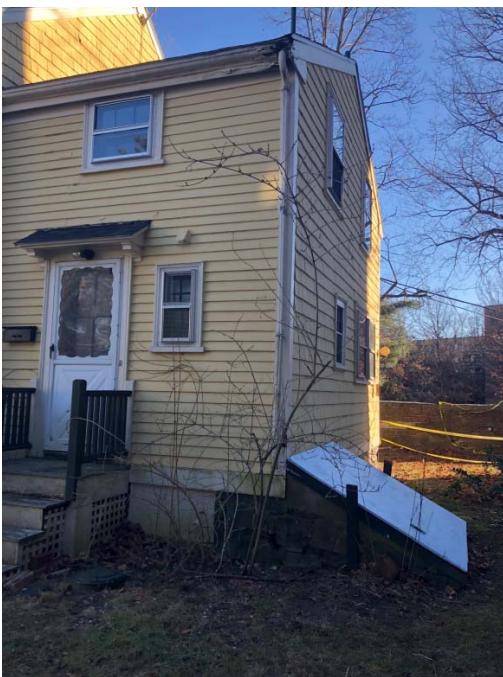
**4. View of back of building**

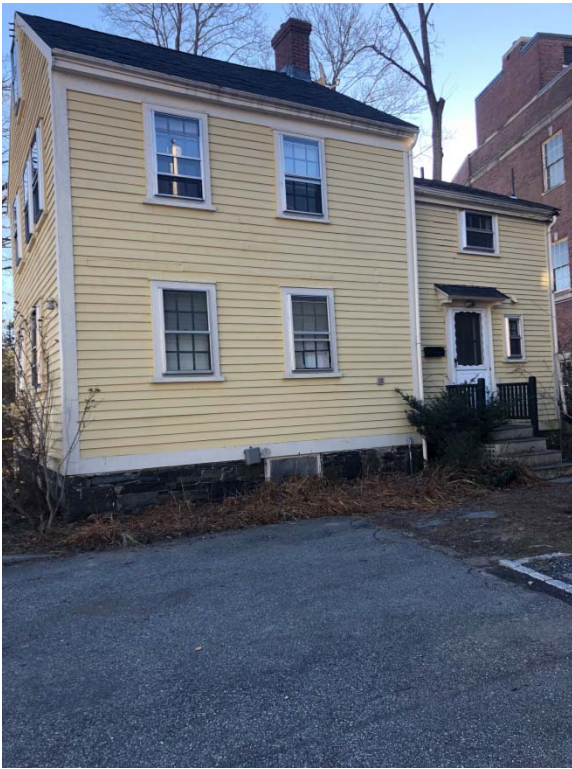
**5. View of west entrance from parking lot**

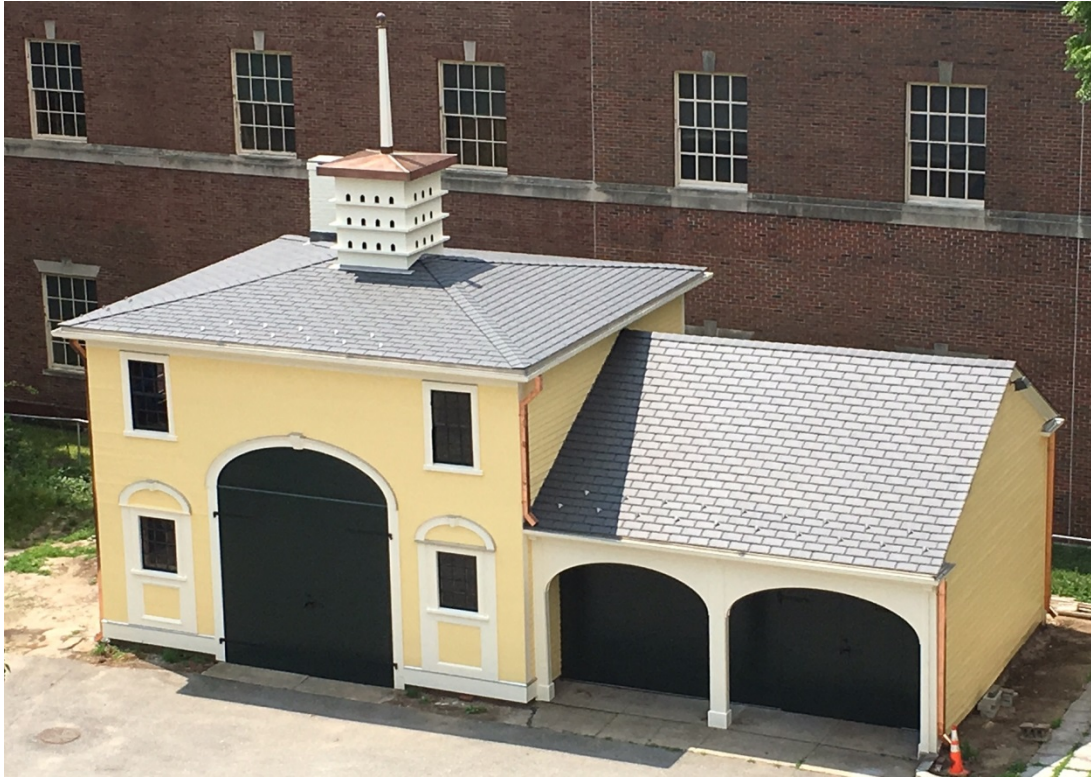
## **Attachment 5. Photo of completed Carriage House 2017**

**Photo of the Whittemore Robbins Carriage House immediately after CPA project completion in 2017. This image depicts the first town owned properties to go through rehabilitation utilization CPA funding.**

All construction will meet the US Secretary of the Interior's Standards for Rehabilitation and performed to professional standards. The Committee that will oversee the project includes individuals who are committed to improving town resources and who have demonstrated experience through the rehabilitation project in 2017 at the Whittemore Robbins Carriage House as shown in Attachment 5.
